# Culm Community Crayfish Project

## CRAYFISH SURVEY REPORT

November 2018

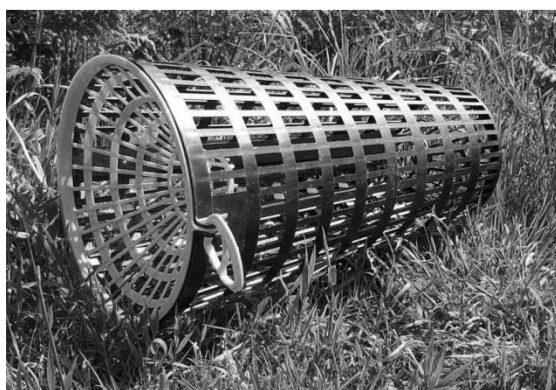
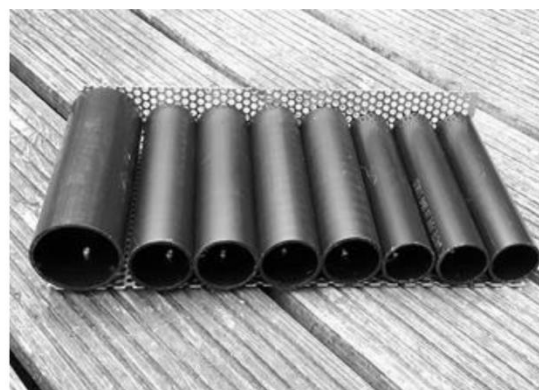
(A)

(B)

**Figure 2. Baited (A) and artificial refuge trap (B)**

Rivers were divided into 500m sections or survey reaches. On the first visit the survey team would undertake a risk assessment followed by a manual search as described above. If no crayfish were found the surveyors would then set 20 ARTs in suitable locations at roughly 25m intervals. The location description, tag number and GPS reading where possible were recorded on a site map. The traps were then left in situ for a minimum of one week to allow them to 'bed in', and then checked up to three times for the presence of crayfish. As soon as crayfish were found the traps would be removed (the exception to this was on the main River Culm where white-clawed crayfish were found - traps were checked 3 times before removal) ; if no crayfish were found after three checks the reach was recorded as negative for crayfish. Any crayfish caught were sexed and measured to the nearest mm carapace length and signs of disease such as porcelain disease were recorded on a survey form. Any signal crayfish found were humanely destroyed in accordance with the relevant legislation (Wildlife & Countryside Act 1981 as amended).

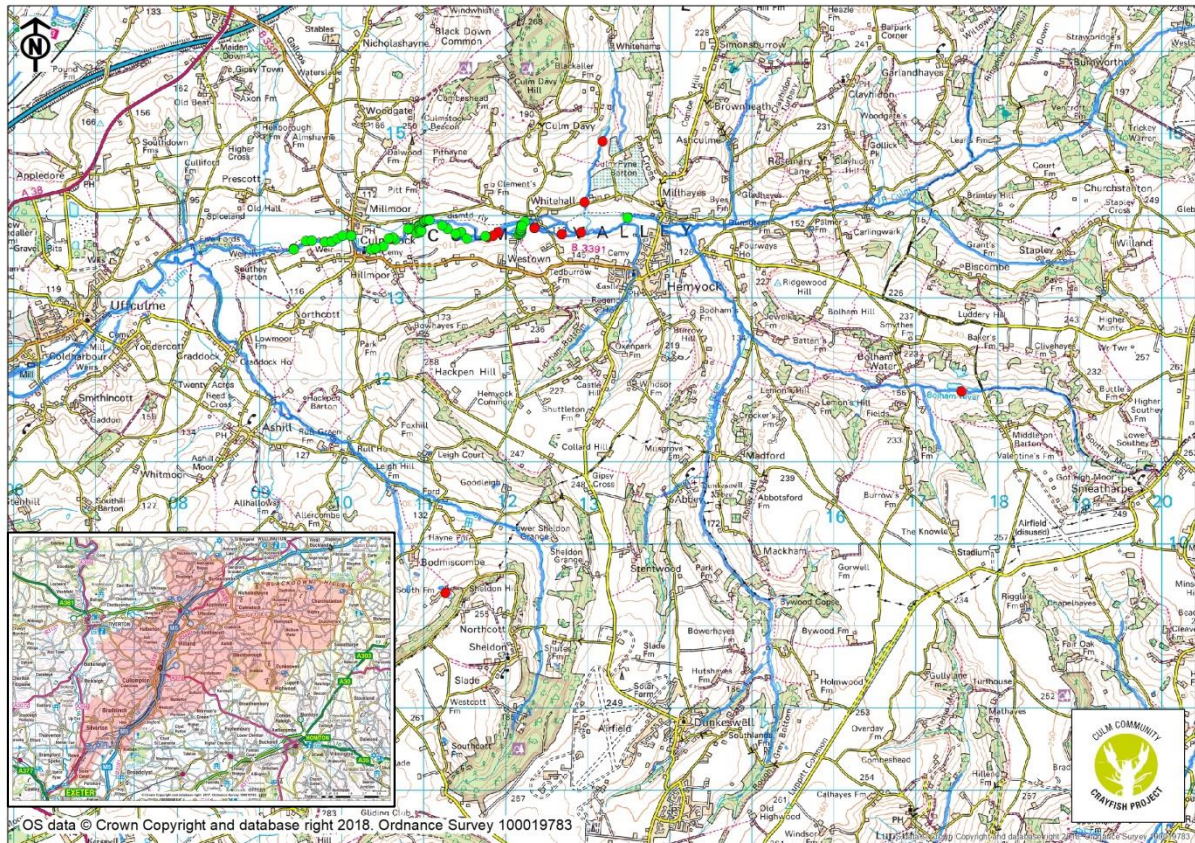
Figure 2. Upper Culm crayfish data to Oct 2017 (catchment map inset)

Historical records for all crayfish species was gathered from the Devon Biodiversity Records Centre and the Environment Agency. In addition, the area of known white-clawed crayfish distribution was surveyed in 2017 as a precursor to this survey. This data was collated and is presented in Figure 2 (Section 3.1).

The desk study provided no additional crayfish records to those already known, though encouragingly white-clawed crayfish were recorded in reasonable numbers throughout the lower extent of their known range during the 2017 survey.

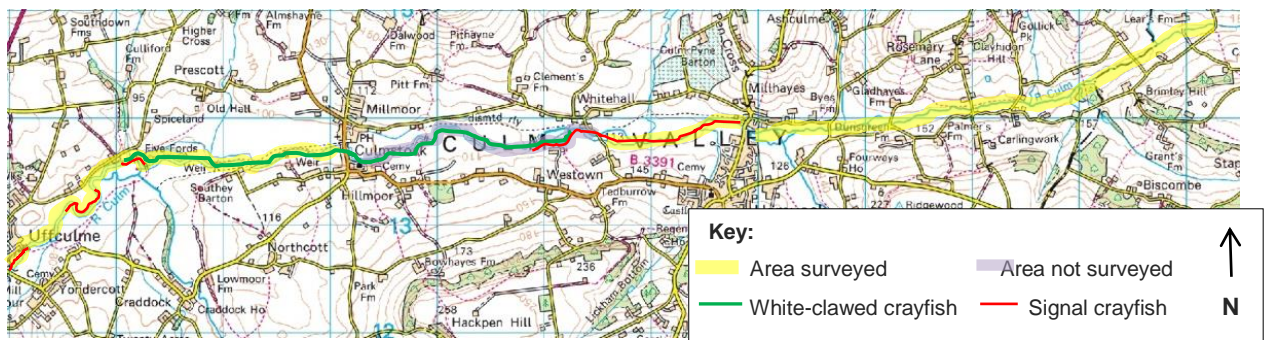
The survey confirmed the continuing presence of white-clawed crayfish, being recorded in an additional four sites extending 2km farther downstream than previously recorded; unfortunately a new population of signal crayfish was also recorded in the Uffculme area at this downstream

limit of the population, albeit in low numbers. An eDNA survey of the Sheldon Stream, which enters the river Culm just upstream of this population, was negative for both signal and white-clawed crayfish. At the upstream end of the population it was found that white-clawed crayfish had disappeared from 1km of river, being replaced by signal crayfish whose population has expanded roughly 1.5km up and 1km down river. They were also found to be in a leat that runs parallel to the main river in this area.

**Figure 4. Survey results River Culm**

It is clear that the white-clawed crayfish population is under severe and imminent threat. Signal crayfish are mixing with and replacing the population at its upstream limits whilst a second population is expanding upstream and mixing with white-clawed crayfish at the downstream end of its range (Figure 4). Furthermore there are two additional populations in tributaries which are expanding downstream towards the main river, one of which carrying the crayfish plague pathogen (refer to Appendix 1 for a summary of all data).

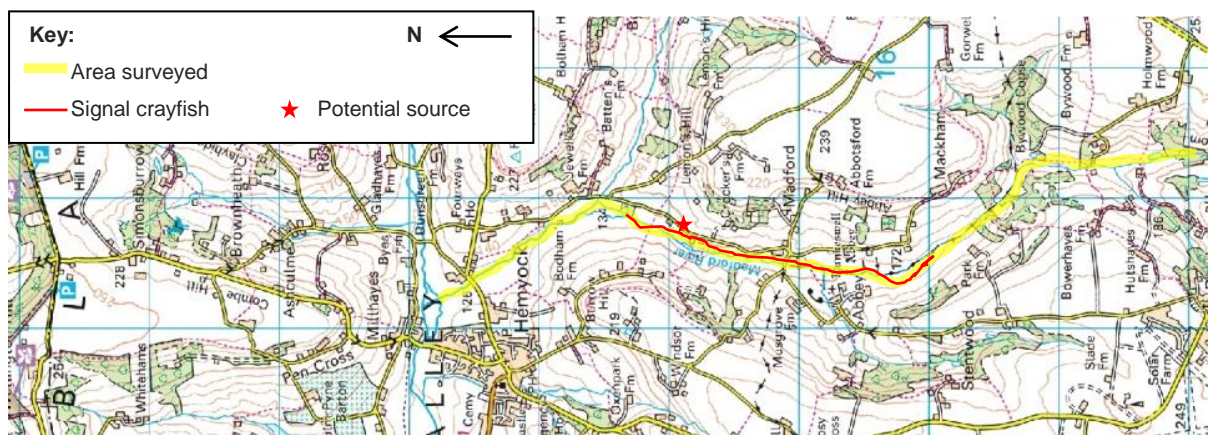
The Madford river was found to support signal crayfish in six of 16 survey reaches (approximately 3km length), with the most downstream occurrence being roughly 1.5km from the confluence with the Culm and 250m from the confluence with the Bolham Water. One source of the population is believed to be an old trout farm, now a carp fishery at ST 14602 11837, consisting of five ponds adjacent to the river (Figure 5). The owners reported seeing crayfish amongst bought-in trout fry some 30 years ago. This source is located towards the downstream extent of the population; since crayfish tend to spread more rapidly downstream than up there may be a second source of crayfish farther upstream. This population was eDNA tested and crayfish plague DNA was recorded. The watercourse tested negative for white-clawed crayfish eDNA.

**Figure 5. Madford River survey results**

Crayfish plague is frequently spread on clothing and angling equipment so its presence in the Culm catchment also presents a risk to other populations of white-clawed crayfish through being spread to other areas as a result of recreational activities such as angling. The current level of angling and biosecurity practices at the potential source site on the Madford (Figure 5) are unknown, but movements out of this site could present a considerable biosecurity risk.

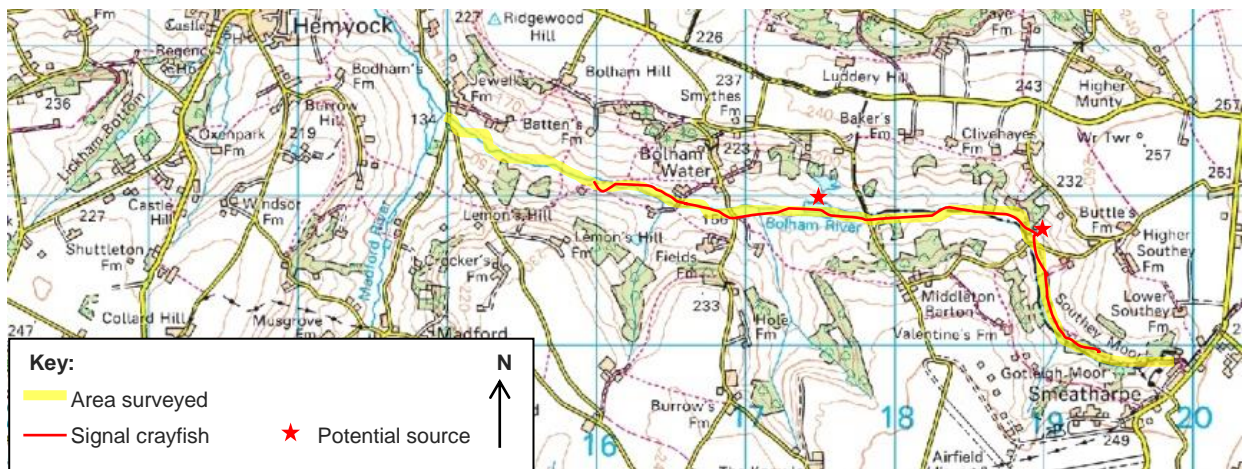
Signal crayfish were recorded along the majority of the Bolham Water, being recorded at 9 of 13 reaches surveyed. The population extends to within 2km of the confluence with the Culm and 1.2km of the confluence with the Madford (Figure 6). It is likely that there are two sources of this population. One is a fishery roughly in the mid-point of the population whilst farther upstream the crayfish reach very high density, implying that there is a secondary source higher up the catchment, and there are two ponds in the area that may have acted as a source. This population was eDNA tested and no white-clawed crayfish or crayfish plague DNA was recorded.

**Figure 6. Bolham Water survey results**
