RAF CULMHEAD, CHURCHSTANTON, SOMERSET
Heritage Environment Programme

PROJECT REPORT

Date of report: December 2015
Copyright: © The author

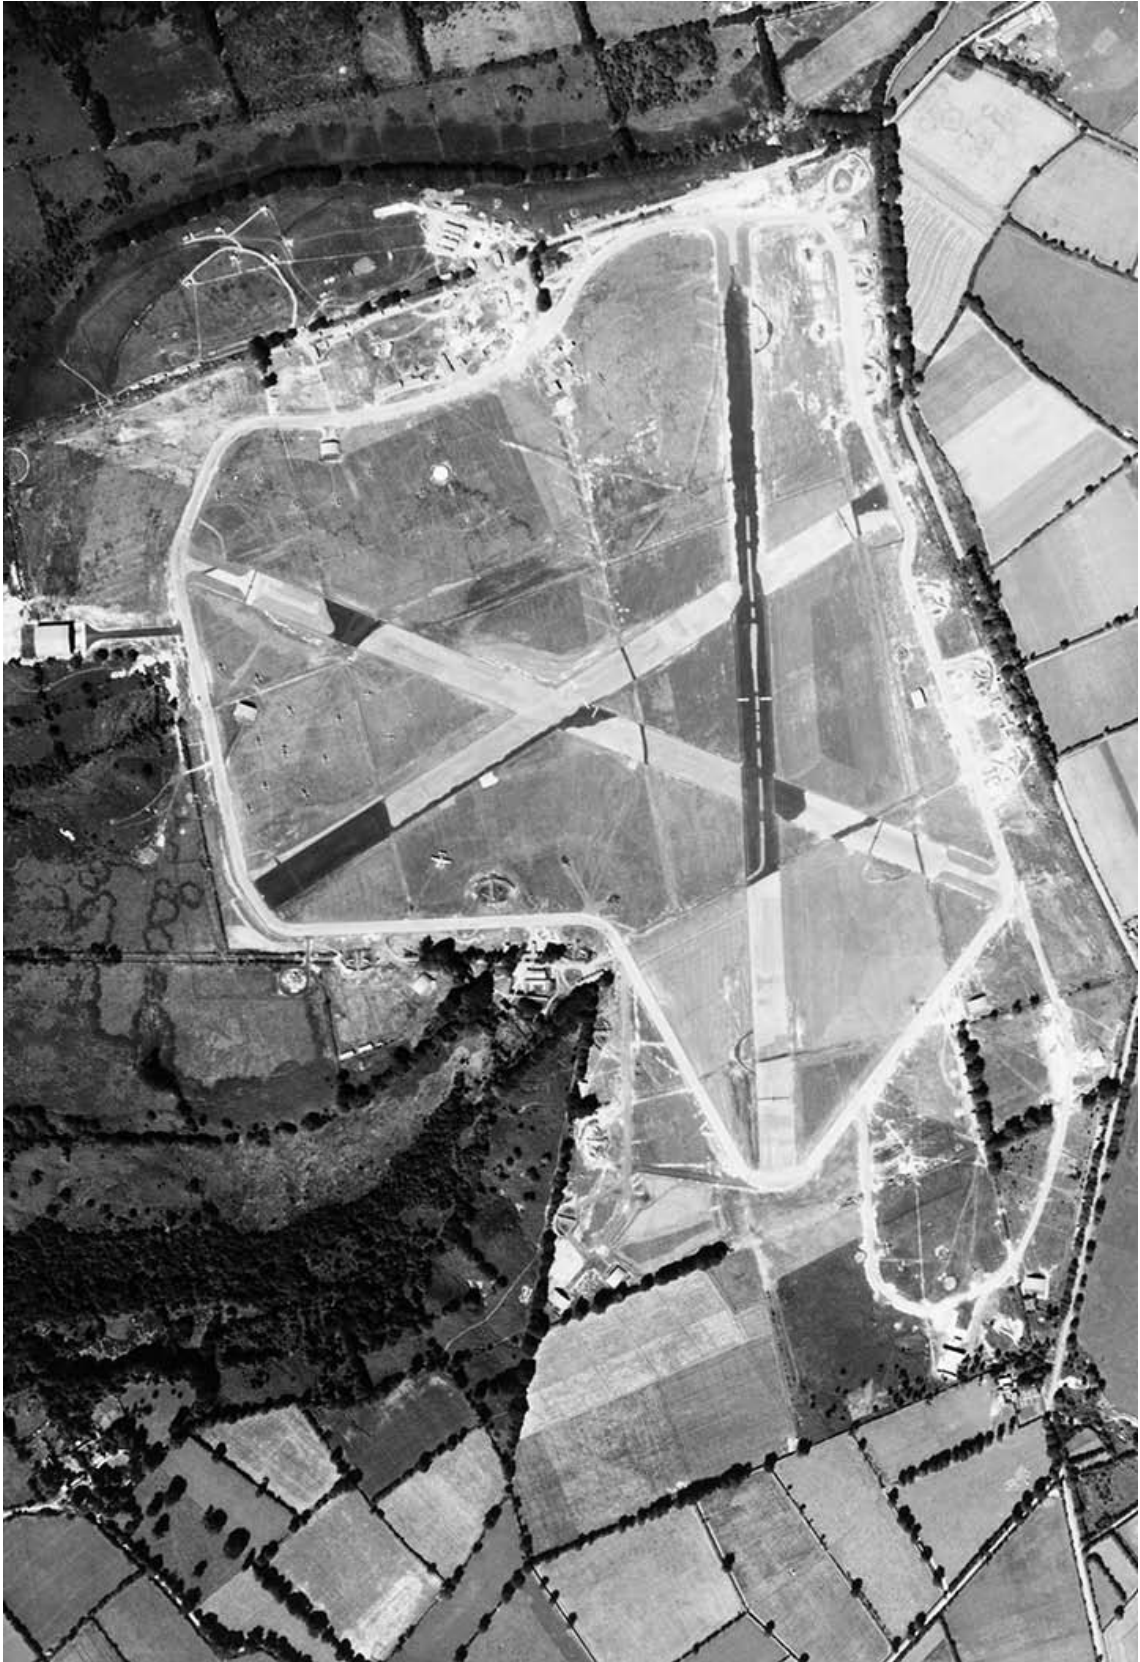
The Airfield Record Site Plan, held in the RAF Museum, Hendon, is a record of the airfield in 1944 (Air Ministry Record Site Plan 4997/45). It records the airfield in great detail, showing the position, function and construction type of each building. Each component of the airfield has a number and an extract from the plan is reproduced in Figure 14. The fully developed airfield is also shown on a remarkable run of air photographs at 1:7000 and 1:3500 scales taken by the USAAF in July and August 1943 (Figs 15,16,39,42,47).

Fig 14 Extract from the Air Ministry Record Site Plan (RAF Museum RSP 4997/45)

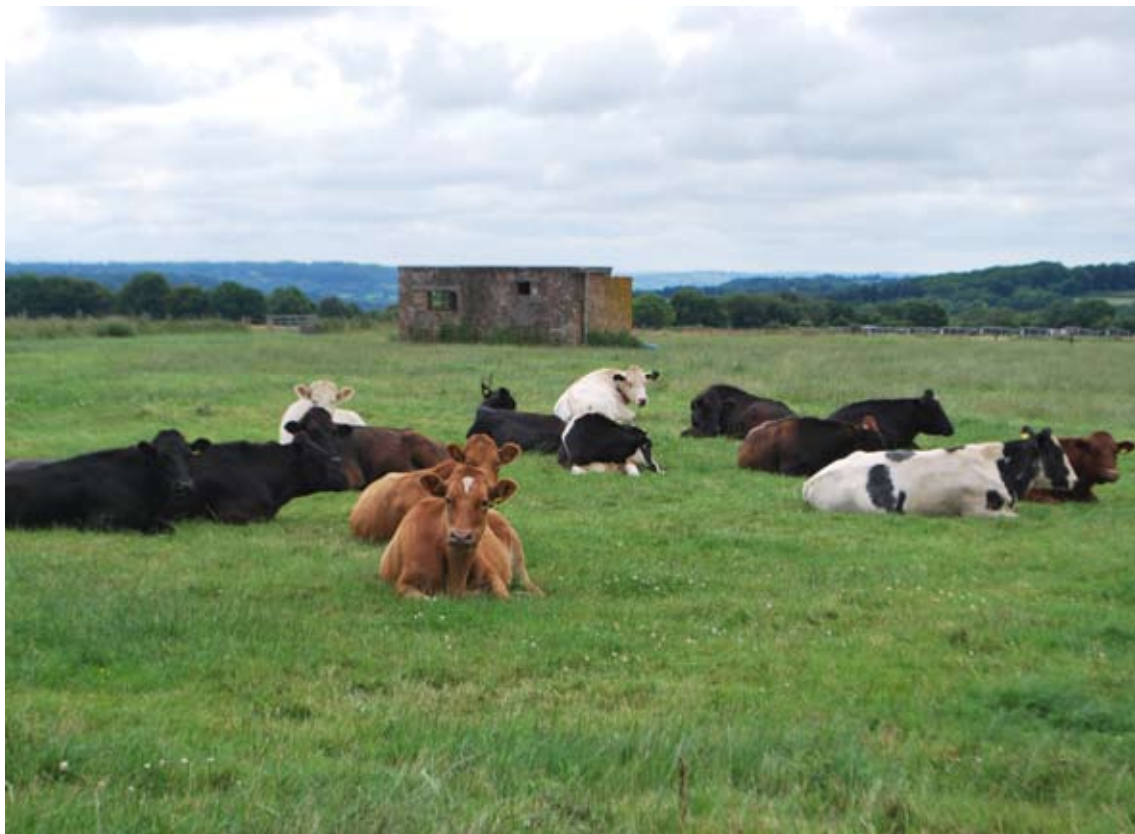
Fig 17 The old watch office in the northern technical area in 2015 (Hazel Riley)

One of the first buildings to be erected on the airfield, in the winter of 1940 to 1941, was a control tower, at that time called the watch office [1A]. This is a single storey building of temporary brick construction, with a blast wall protected entrance leading to a gas proof door. It stands to the north of the northern perimeter track of the airfield. This gave access to a single room – the watch office - with three windows facing the runway on the south side and a single window on the west and east sides (Fig 18). A pyrotechnic cupboard in one corner still has a gas proof steel door (Fig 19). The cupboard was used to store flares which were fired from Very pistols, providing a simple signalling system. The watch office was the air traffic control building for RAF Culmhead until 1943, when it was replaced by a two-storey control tower. The building became known as the old watch office and had a new function: a battery charging room. A bench below the windows dates from this time and still has the following lettering on its side: NOT CHARGED and DISTILLED WATER.

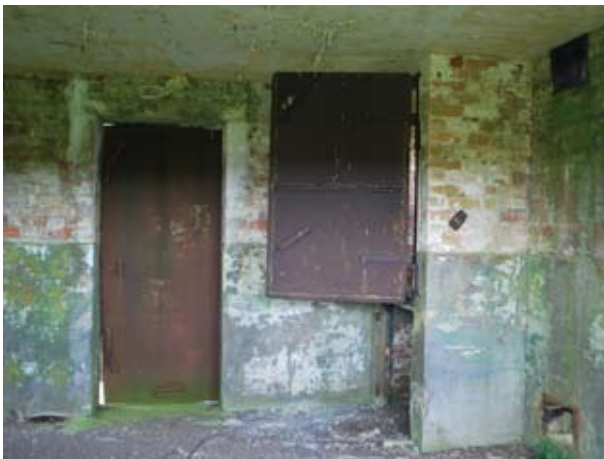
Fig 19 (above left) The pyrotechnics cupboard in the old watch office (Hazel Riley)

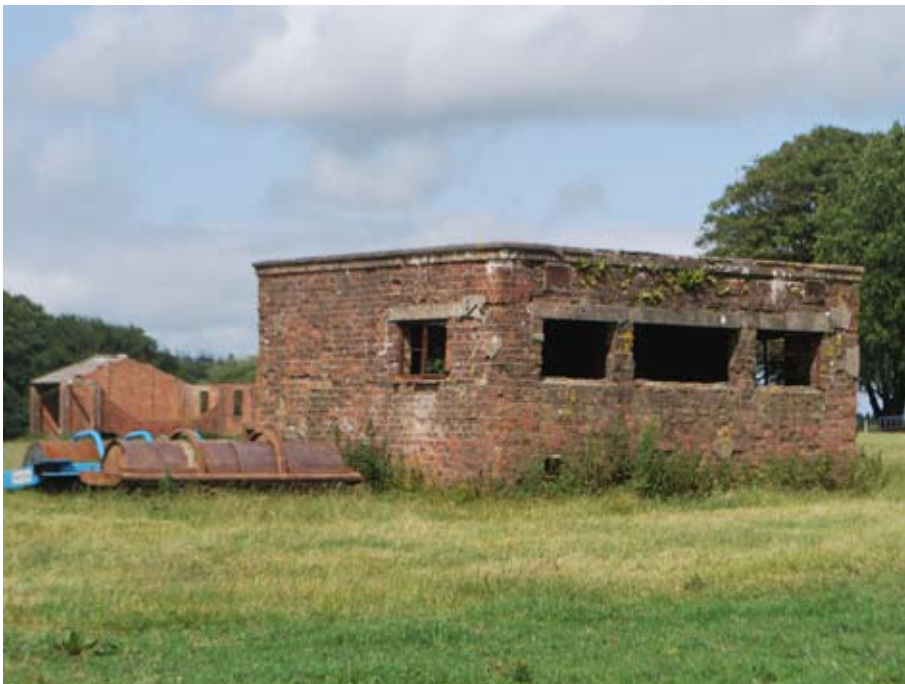
Fig 18 (left) The south side of the old watch office (Hazel Riley)

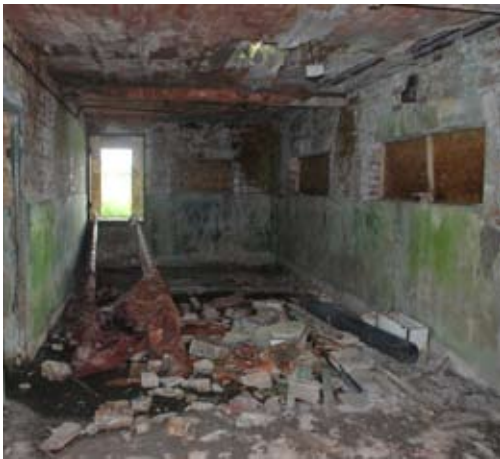
*Fig 20 (above)
The watch office
in the control
tower (Hazel
Riley)*

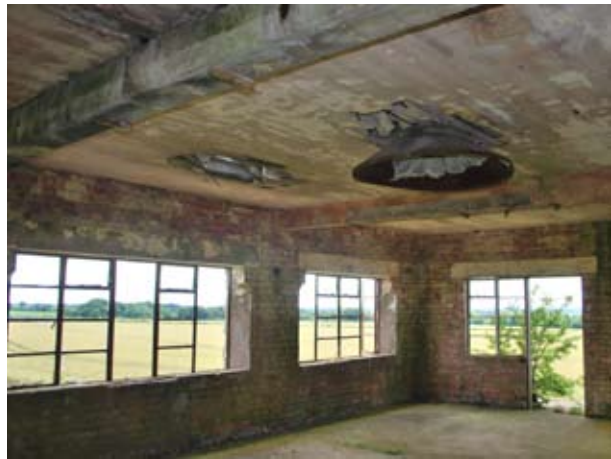
*Fig 21 (above
right) The control
room (Hazel
Riley)*

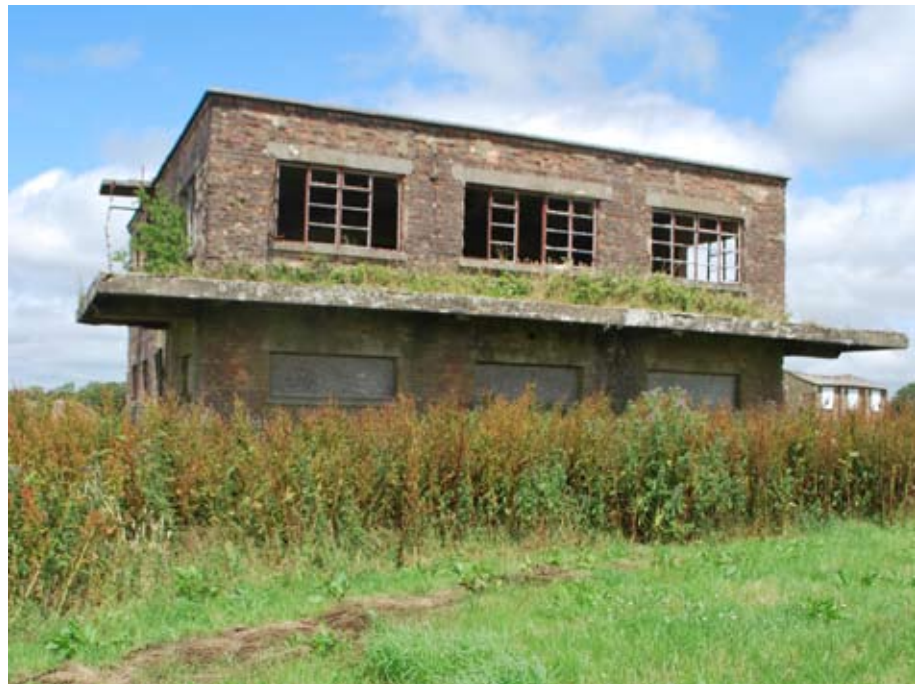
The size of the building compared to the old watch office reflects the increasing need to regulate local air traffic control at RAF stations. The rooms on the ground floor housed the meteorological office, latrines, the duty pilot's rest room, the switch room and the watch office. The upper floor housed the signals office, the controller's rest room and the control room (Figs 20 and 21). A concrete balcony, accessed by a door in the west wall, runs around the control room and also gave access to the roof by a metal ladder (Fig 22).

*Fig 22 The
control tower
balcony (Hazel
Riley)*

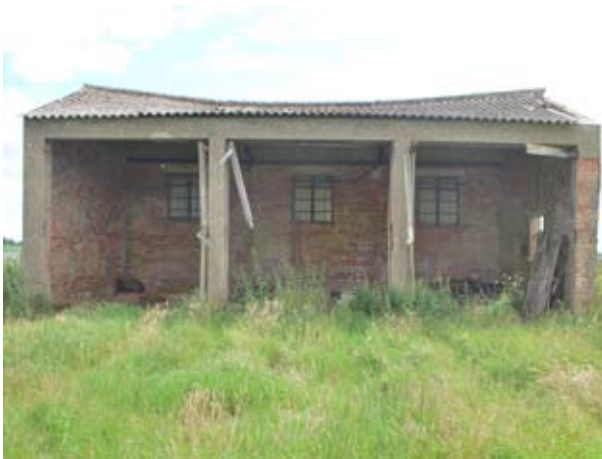
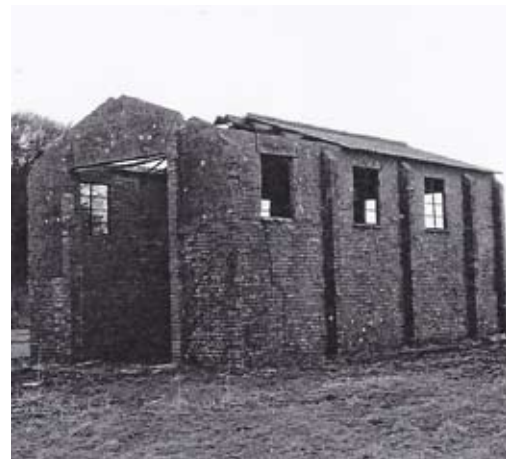
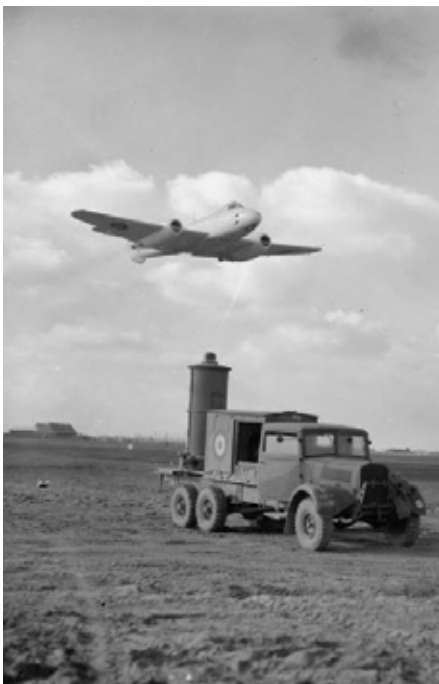
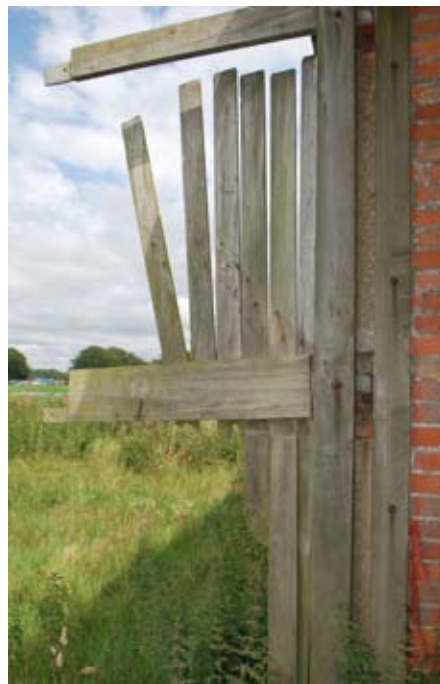
There was no permanent electric lighting for the airfield at RAF Culmhead, instead a portable lighting system was used. A portable floodlight on a three-wheeled trolley, was plugged into electrical sockets on the side of the runway, or a self-powered Chance light on a four-wheeled trailer was moved to the side of the runway (Fig 23). Other night-flying equipment, such as glim lamps (portable electric runway lights), Paraffin flares for use in emergency conditions, and an illuminated landing tee were also used (Francis 1997, 29). The equipment was kept in two buildings between the control tower and the old watch office. The night-flying equipment store [29] stands 60m to the NE of the control tower (Fig 24). It is a large, temporary brick building, divided into three bays with the remains of heavy wooden doors and the concrete hurters which protected the building from traffic damage (Fig 25). The floodlight tractor and trailer shed stood to the west of the store; it was demolished after 1997 (Fig 26). The nearby airfield at Upottery had a searchlight detachment operating on the edge of the airfield for searchlight homing so that aircraft returning at night could find their way back to Culmhead or Upottery airfields by using the light beam as a signal (Francis 1995, 93).

Fig 23 (far left)
A Chance light
on the runway
in Belgium with
Gloster jet of
616 Squadron
(© IWM C5658)
Fig 24 (top left)
The night-flying
equipment store
(Hazel Riley)
Fig 25 (left)
Detail of door
(Hazel Riley)
Fig 26 (top right)
Floodlight trailer
& trailer shed
in 1997 (Paul
Francis for SCC)

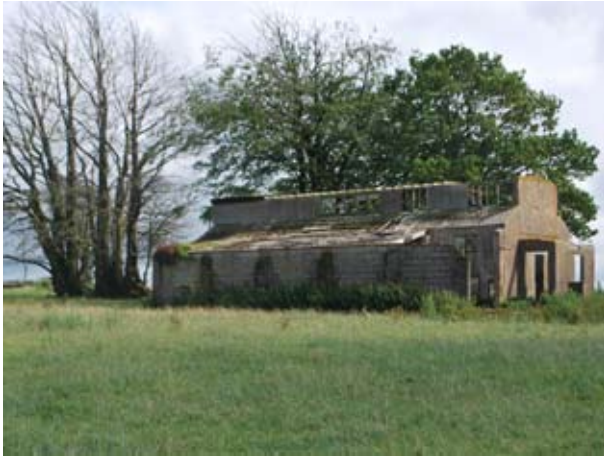
The parachute store [30] lies c 120m to the north of the old watch office. It is a large building of temporary brick rendered internally and externally, with external piers forming five bays each 10 feet long. A later lean-to was built onto the northern side for livestock housing. A lobby provides access to the main room on the west wall. The roof is a symmetrical two stage pitched roof, with window lights, now in a poor condition. These features reflect the specialised nature of this building. Parachutes became standard equipment for aircrew from 1927. They were inspected every month to ensure they were fit for service: one of the main problems was condensation and the parachutes had to be dried properly to prevent shrinkage. The building had to provide a dry atmosphere with constant ventilation and a temperature of 55-65° F. The lobby helped to keep the building free of dust and to maintain an even temperature. The main drying room had to be high enough for the parachutes to be suspended from their tops without touching the floor, and large, smooth-topped tables were needed for inspecting and packing the dried parachutes. The parachutes were winched up and down with a pulley system on the ceiling near the centre of the room. The work was usually carried

out by WAAFs. (Fig 27) (Francis 1996, 32-34). The parachute store at RAF Culmhead is built to one of the earlier AM designs and is probably one of the earliest buildings on the site (Fig 28). Although the interior has suffered damage due to later modification and the collapse of the roof, the wooden rafters and five wooden windows in the upper roof, metal window frames and electrical switch box can still be seen (Fig 29).

Fig 28 (top) Parachute store with lobby & 2 stage roof (Hazel Riley)

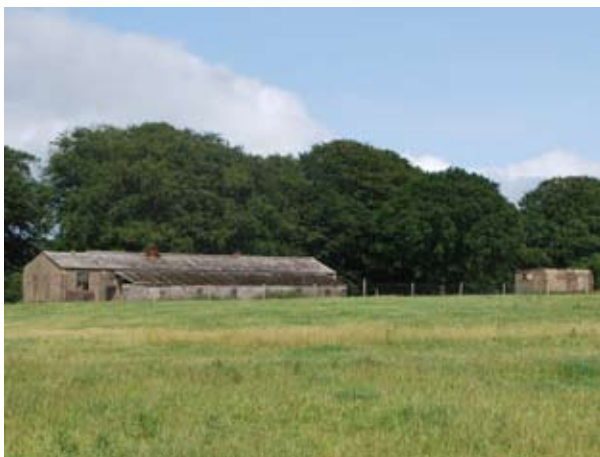
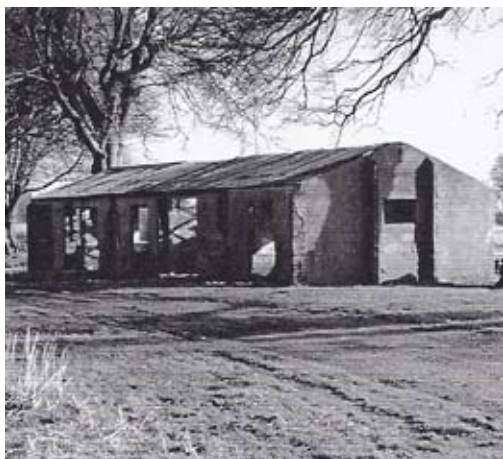
Fig 33 (opp left) Door in gas clothing store (Hazel Riley)

Fig 34 (below right) Base of gas defence centre, gas chamber and gas clothing store in background. Mound to left is on site of station's main workshop (Hazel Riley)

Several grass covered mounds mark the sites of demolished and infilled blast shelters, provided for the personnel working on the technical site; a large mound lies on the site of the main workshops for the station and probably represents substantial amounts of demolition material and rubble (Fig 34).

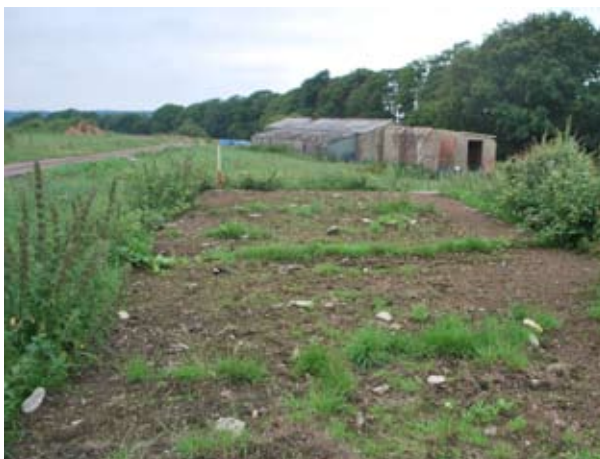
The motor transport section was an important part of an RAF station, responsible for the garaging, repair and maintenance of all the vehicles. The section was based at the motor transport yard: a vehicle shed opposite a large Nissen hut, housing stores, offices, rest rooms and latrine, with a large concrete yard in between (Francis 1996, 36). At RAF Culmhead the vehicle or motor transport shed [25] survives. It stands 180m to the NE of the old watch office and is a large temporary brick building with four bays, the most common Second World War design. There is a vehicle inspection pit in the northern bay and vehicle inspection ramps on the south side of the shed (Fig 35) (Francis 1996, 32-39).

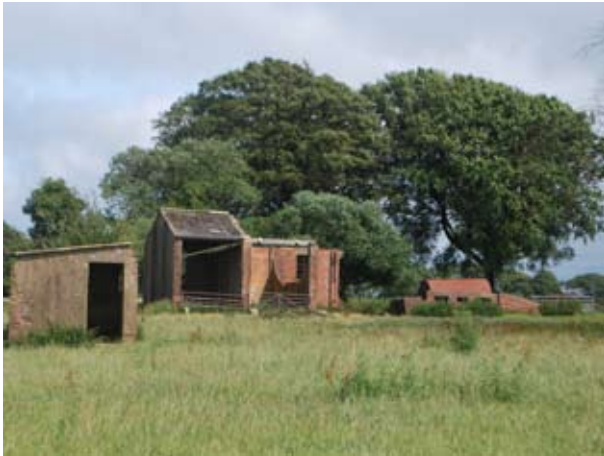
Fig 35 (left) The motor transport shed and inspection ramps. Latrine block for the parachute store on the left (Hazel Riley)

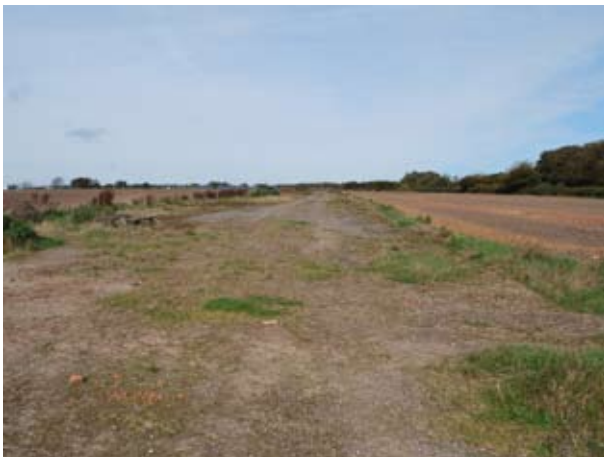
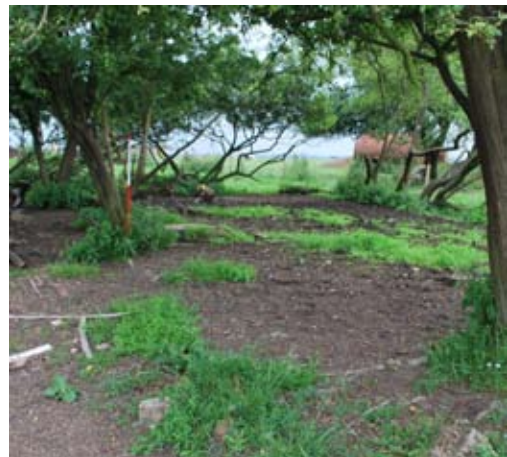
A large, rectangular concrete plinth to the east of the vehicle sheds (Fig 36) is the base for a building identified on the RSP as the W/T transmitter building [11] and demolished by 1997. Long range wireless telegraphy was used for communicating over a long distance, for example from the station to the aircraft, and each airfield had its own W/T station to keep contact with their own aircraft. They were usually sited some distance away from the airfield. The transmitter building housed radio transmitters and was surrounded by aeries. This site at RAF Culmhead is an unusual position for such a building, in the technical area and close to the control tower, rather than dispersed away from the main airfield.

Fig 36 (below) The base of the W/T transmitter building, as recorded on the AM RSP (Hazel Riley)

Fig 37 (below left) Eastern airfield perimeter track (Hazel Riley)

There are three tarmac runways and a perimeter track encompassing the airfield. Some of the runways are used for farm access between fields; the perimeter track is used by farm vehicles and service vehicles for the solar arrays. Part of the access track to the SW dispersal area is part of the off-road vehicle test area (Fig 37).

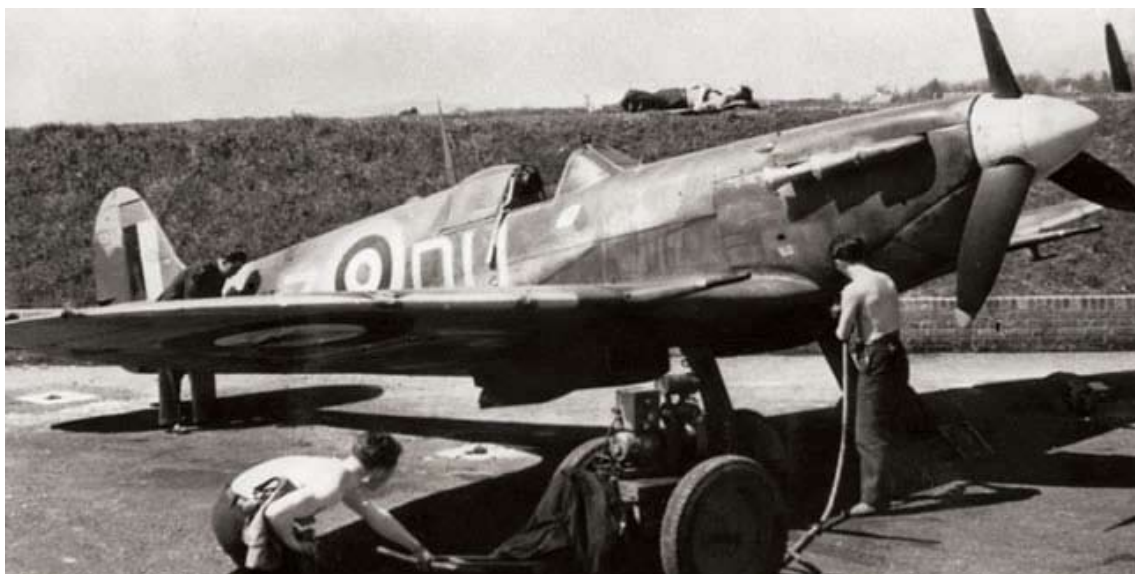
Bomb blast was thought to be the biggest threat to aircraft dispersed out on the airfield and for this reason specialised structures – fighter pens - were built on fighter stations to protect the aircraft and the air crew. Twelve fighter pens were built at RAF Culmhead, they were probably completed by October 1942. An aerial photograph taken in June 1942 which shows heavy wear on the access tracks to the fighter pens and dispersal areas suggesting that they were under construction or recently completed, and a photograph, believed to be of one of 312 Squadron's Spitfires in a fighter pen at RAF Culmhead c June 1943 shows pristine, grass-covered traverses, dwarf brick walls and tarmac apron (Fig 38).

Fig 38 Spitfire DU-7 in fighter pen, probably at RAF Church Stanton, c June 1943 (Flying Heritage Collection)

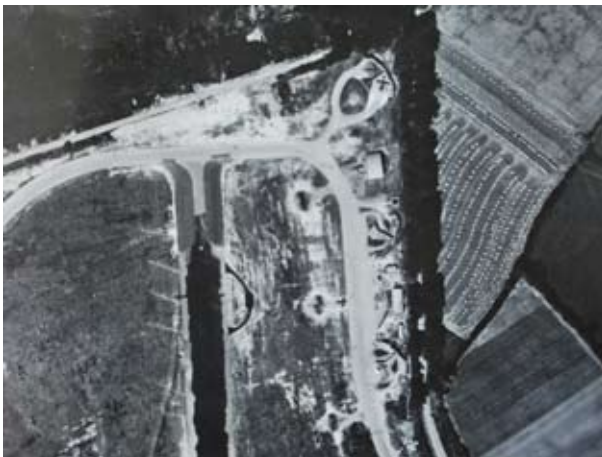
There were two groups of fighter pens at the airfield, each group arranged in two sets of six fighter pens, and each group of six had its own flight office accommodation buildings and at least one blister hangar. All the fighter pens were built to a particular specification: Type B, a larger size, designed to house two aircraft of a size similar to that of the Bristol Blenheim. Aerial photographs and maps show that the two groups of fighter pens at RAF Culmhead were similar in size and layout, but different in construction and defence provision. The two groups of pens laid out along the eastern perimeter airfield track were demolished some time after 1963 and before the 1997 survey took place, so there is little information about them (www.old-maps.co.uk OS plan 1963 1:2500). However, they are clearly visible on the USAAF air photographs, and it is suggested that they were built of sandbag walls, with a brick air raid shelter constructed in the front of the central arm, and that two of the pens had a defended wall at the front of their shelters (Figs 14 and 39) (Francis 1997, 8). The only surviving building is a latrine block from the NE dispersal area (Fig 40).

Fig 40 (below) The latrine block for the NE dispersal area and fighter pens (Hazel Riley)

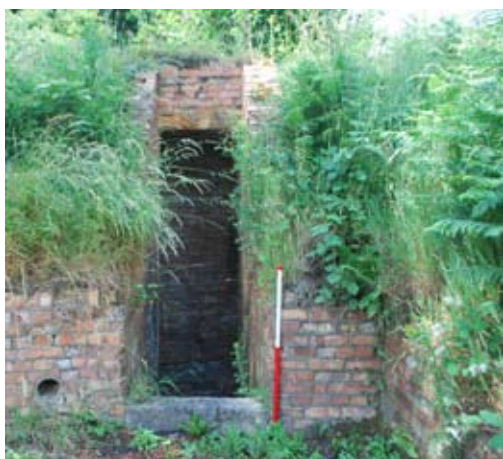
The SW dispersal area contains three fighter pens [226,227,228], arranged off a track which can be accessed from two points along the SW airfield perimeter track (Fig 42). Each fighter pen is constructed from earthwork banks – traverses – revetted by low brick walls, forming two protected pens for two aircraft on tarmac hard standing. At the back of each pen is a pre-cast Stanton type air raid shelter for 25 personnel which can be accessed from both pens (Fig 43).

Fig 42 (left) The fighter pens and blister hangars in the SW dispersal area (US 7PH GP LOC 14 5036) (Historic England USAAF Photography)
 Fig 43 (above) Access to Stanton air raid shelter at back of fighter pen 227 (Hazel Riley)
 Fig 44 (above right) Defended wall, fighter pen 227 (Hazel Riley)

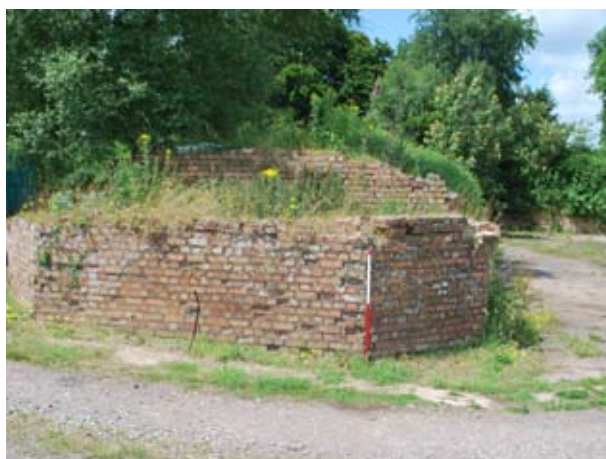
Each of the pens has a different arrangement of brick defended walls, with gun loopholes. Two pens have defended walls which look out across the country to the west, two have defended walls on the end of the central traverse which look out across the airfield, the other has a defended wall facing the nearby blister hangars (Fig 44).

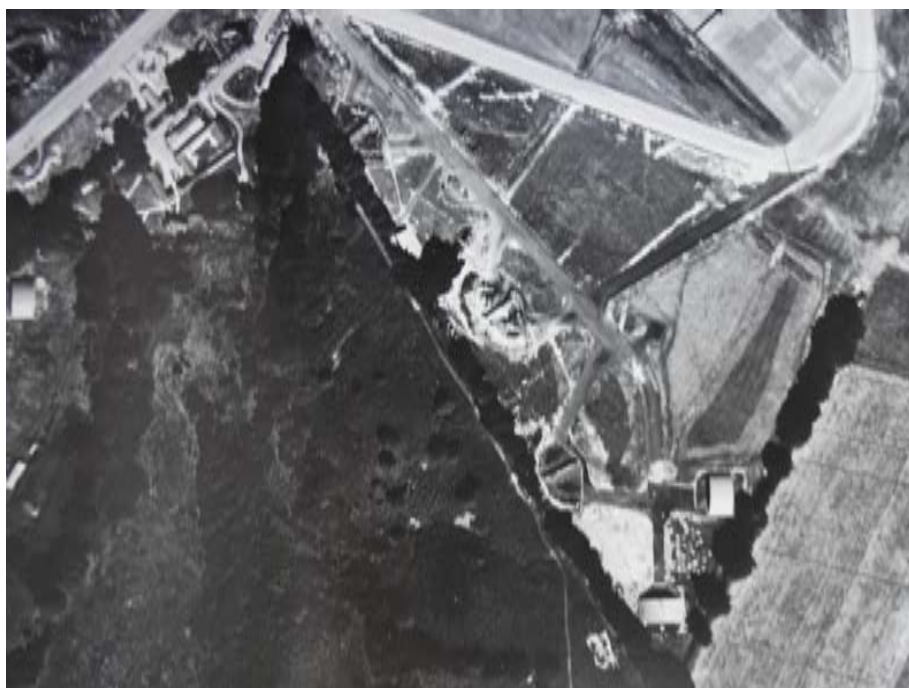
The flight accommodation buildings – an office [199] and latrines [198] – lie between fighter pens 227 and 228 and a large concrete base, the base for a 24 feet long Nissen hut housing one of the two station squadron offices lies between fighter pens 228 and

Fig 45 (top left)
Flight office for
SW fighter pens
(Hazel Riley)
Fig 46 (above)
The squadron
office in 2004
(Graham 2004,
pl 3)
Fig 47 (left) The
west dispersal
area: 3 fighter
pens, flight &
squadron offices,
fuel installation
(US/7/PH/GPI
LOC 14 5040)
(HE USAAF
Photography)

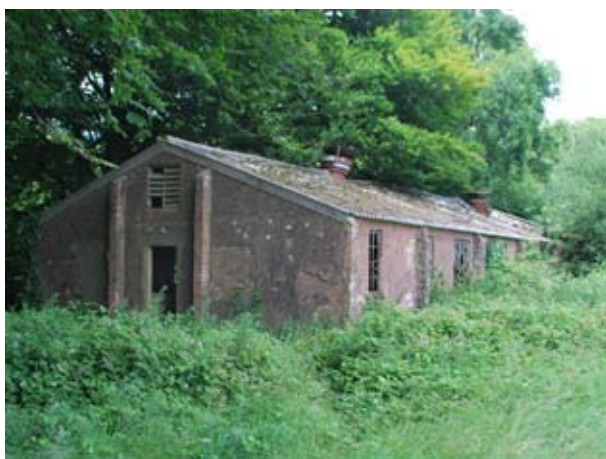
229, at the top of Trickey Warren Lane (Figs 45 and 46). The Nissen hut structure [2A] was dismantled, with SM consent, in 2004 (Graham 2004) and the second squadron office, in the northern technical area, was demolished before the 1997 survey took place.

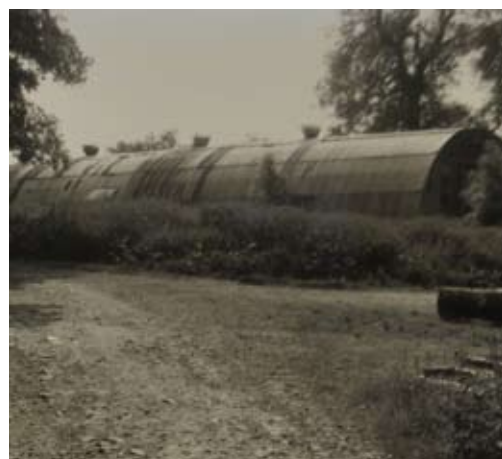
The western dispersal area is accessed by short tracks from the western airfield perimeter track. One of the fighter pens, now demolished, was constructed on the airfield side of the perimeter track. The 1943 air photograph clearly shows it had a defended wall facing across the airfield (Fig 47). The two which survive lie on the edge of Trickey Warren Lane. Fighter pen 229 has a defended wall built into the rear exit of its air raid shelter and a defended wall at the end of its central traverse, facing the airfield. Fighter pen 231 has three defended walls: to the SW, west and NE (Figs 48 and 49).

plinth which housed a step-up transformer, fed from the intake sub-station, to maintain a constant voltage. One of the airfield's two aviation fuel installations was located on the edge of Trickey Warren Lane, west of fighter pen 231. This held four 12 000 gallon tanks and a pump house, with hard standing and access for petrol tankers. The site has been cleared but the circular access track still remains and it can be clearly seen on the 1943 air photographs (Fig 47).

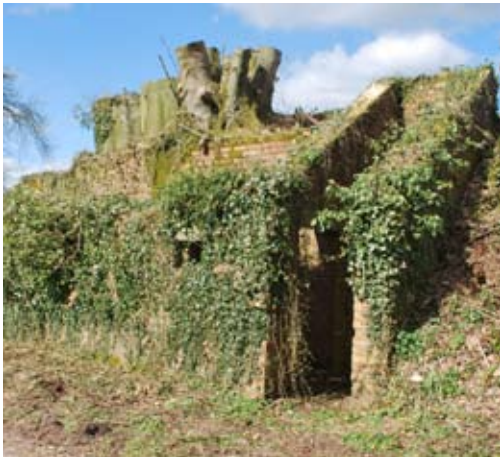
*Fig 48 (above)
Defended wall
over the air raid
shelter, fighter
pen 229 (Hazel
Riley)*

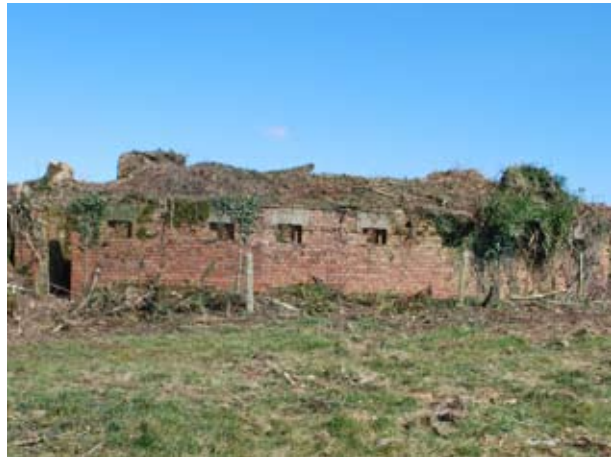
*Fig 50 (right)
Flight office for
the western
dispersal area
(Hazel Riley)*

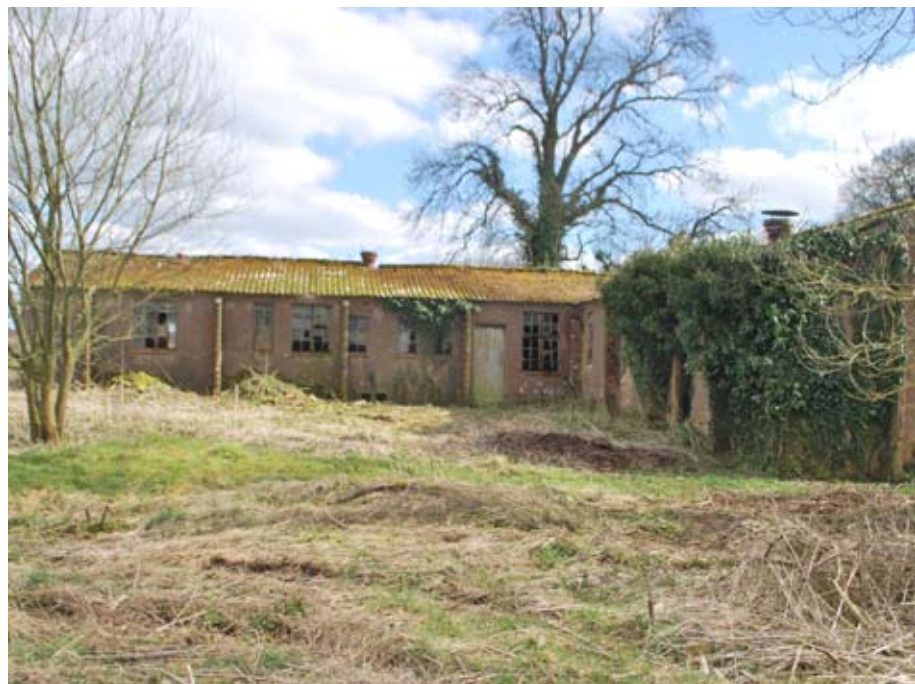
The T-shaped flight office [200] and latrine block [201] stand to the west of fighter pen 229 (Fig 50), and a small brick building to the east of fighter pen 231 is a transformer

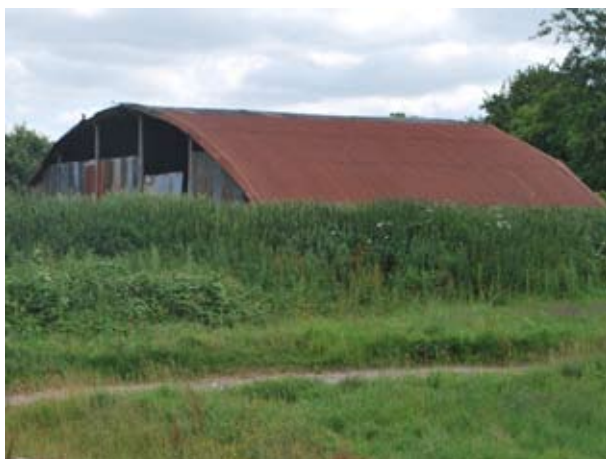
Blister hangars are small arched-type dispersal sheds for the dispersal and maintenance of aircraft with small wing-spans (Fig 51). The one remaining hangar [214] at RAF Culmhead is a Miskins 'over type', made of welded steel rib sections bolted together to form the arches. The arches were joined by steel ties and steel or timber purlins roofed with corrugated iron sheeting. This formed a building with a span of 65 feet, a length of 45 feet and a height of 19 feet 10 inches. The ends were covered with quick release canvas curtains (Francis 1996, 106-107). The hangar at RAF Culmhead has been used for storage and has been repaired and the ends filled in with timber and metal sheets, but it retains a large amount of original steelwork and corrugated roof sheets; the survival of what was intended to be a temporary structure is notable (Figs 52 and 53).

Fig 51 (left)
Spitfire in
blister hangar,
RAF Fairlop
1942 (© IWM
TR514)

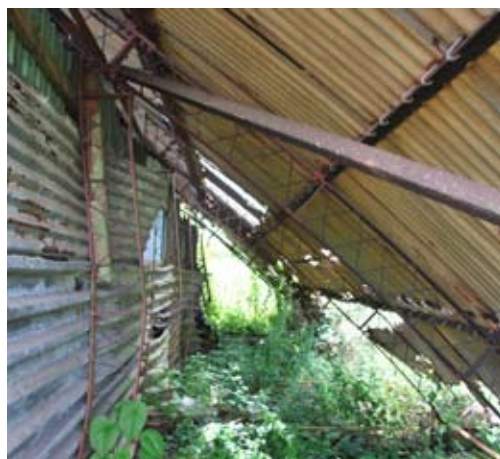
Fig 52 (above
left) Blister
hangar RAF
Culmhead
2015 (Hazel
Riley)

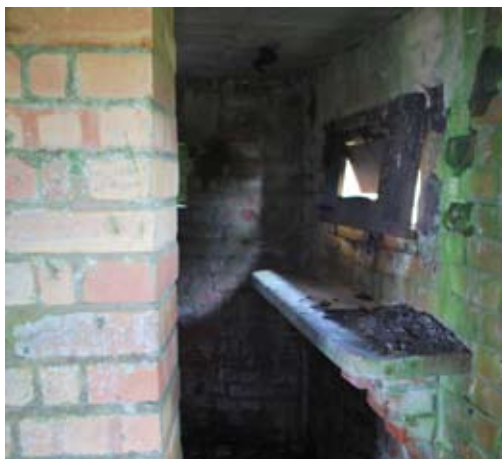
Fig 56 (below) Heavy machine gun loophole, metal shutter, firing shelf & anti-ricochet wall (Hazel Riley)

one or two large openings for a heavy machine gun, located on different walls on each pillbox in a group of three, enhancing the effectiveness of the position. Steel shutters, firing shelves and anti-ricochet walls survive in several pillboxes (Figs 55 and 56). The gunpits [530,531] for the west and south defensive positions are built into hedge banks. The gunpit 530 by fighter pen 231 is in the best condition, it is a keyhole shaped, brick-lined pit with the gun mount in the circular section still in position: a Motley stalk anti-aircraft machine gun mount, and a small store for an ammunition box built into brick lining by the gun mount (Fig 57).

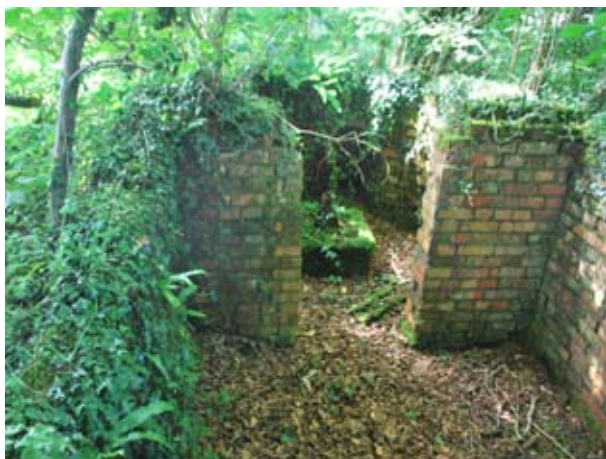
The Somerset Light Infantry were responsible for the defence of many of the airfields in the county in the Second World War, and in March 1942 D Company took over the airfield defences at RAF Culmhead, assisted by the RAF Police and parties of armed airmen. A ground defence exercise was carried out on 20th April 1942, when commandoes attacked the airfield, destroying or damaging several aircraft, two fuel bowisers and a tender (Berryman 2006, 53). In early October 1942, 2861 Squadron RAF moved from Llanbedr in SWales to take over the station's defences from the Somerset Light Infantry who moved to Yeovil. The accommodation for the defence units was on the edge of the airfield. There were barrack blocks sited along the hedges between the two groups of pillboxes on the northern side of the airfield, either side of the hedge between the T2 hangar and the SW group of pillboxes, and in the southern dispersal area. Several of the Laing and Nissen hut bases are still extant (Fig 58).

Fig 58 (left) Base for Laing hut (Hazel Riley)

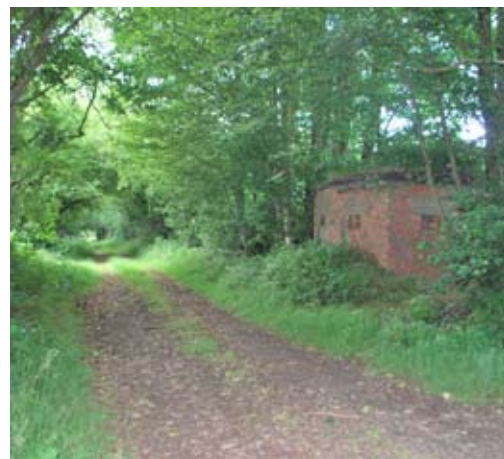
Fig 59 (below) Trickey Warren Lane & pillbox/quadrant post for practice bombing range (Hazel Riley)

store are still part of the farm yard. at Glebe Farm. Trickey Warren Lane was the centre line for a practice bombing range to the west of the airfield; pillbox 522 functioned as a quadrant post for the bombing range (Fig 59).

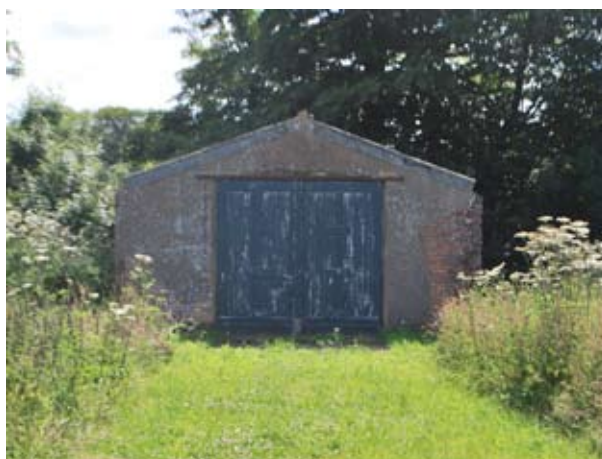
*Fig 4 Example of good practice: vegetation control at structure **201** (Hazel Riley)*
